**Flood Control Project Maintenance  
Levee Inspections**

## Maintenance Issue Types Only, Levee Inspection Report By Mile - Spring 2019

### Reclamation District No. 0556 Upper Andrus

Waterway	Bank	Unit Miles	Inspection Start/End	Inspector
Unit No. 01 Georgiana Slough	Right	5.48	03/21/2019 03/21/2019	David Julian

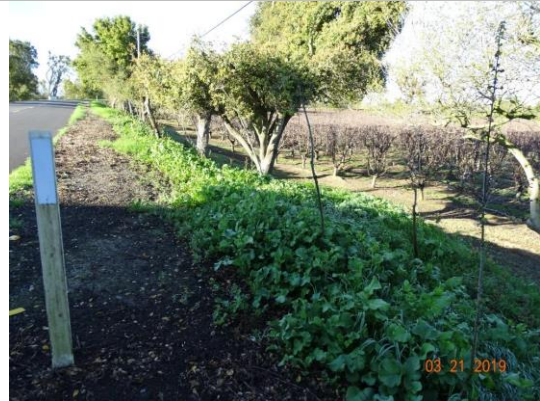
Photo 1 of 1 : SP\_2019\_RD0556\_18\_19\_20190321\_00072.jpg

LM Start	0.98	Rating **	M	Issue No.	19
LM End	1.02	Issue Type +	Ma	Location *	LS
Category	Earthen Levee			GPS Latitude/Longitude	
				Start	End
Item	Vegetation			38.227710 °	38.227098 °
				-121.527037 °	-121.527188 °
DWR ID	DWR_RD0556_01_s_2019_19				
Comment Code					
V1 : Control annual grass and weeds on the levee slopes and easements.					
Inspector Comment					
Maintain vegetation on landside slope.

View looking downstream at vegetation on the landside shoulder and slope (Spring 2019).

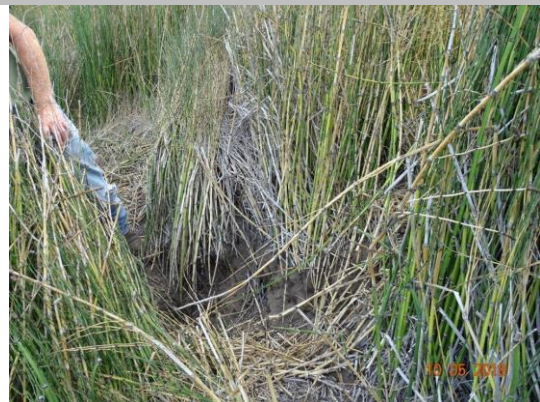
Photo 1 of 1 : SP\_2019\_RD0556\_18\_40\_20190311\_00024.jpg

LM Start	1.43	Rating **	M	Issue No.	40
LM End	1.43	Issue Type +	Ma	Location *	LS
Category	Earthen Levee			GPS Latitude/Longitude	
				Start	End
Item	Erosion / Bank Caving			38.226537 °	38.226537 °
				-121.533512 °	-121.533512 °
DWR ID	DWR_RD0556_01_f_2012_40				
Comment Code					
E1 : Note and monitor erosion site.					
Inspector Comment					
Erosion is covered by vegetation.

View of erosion that is covered by vegetation on the landside slope (October 2018).

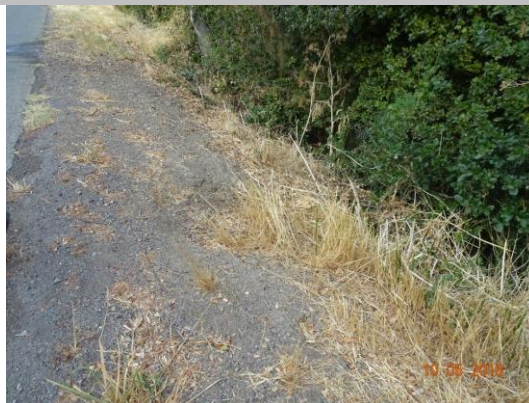
Photo 1 of 1 : SP\_2019\_RD0556\_18\_22\_20190311\_00003.jpg

LM Start	1.50	Rating **	M	Issue No.	22
LM End	1.69	Issue Type +	Ma	Location *	LS
Category	Earthen Levee			GPS Latitude/Longitude	
				Start	End
Item	Erosion / Bank Caving			38.225840 °	38.224360 °
				-121.534157 °	-121.537125 °
DWR ID	DWR_RD0556_01_s_2012_22				
Comment Code					
E1 : Note and monitor erosion site.					
Inspector Comment					
Dip at the top of the landside slope is greater than 3".

View of dip at the top of the landside slope (October 2018).

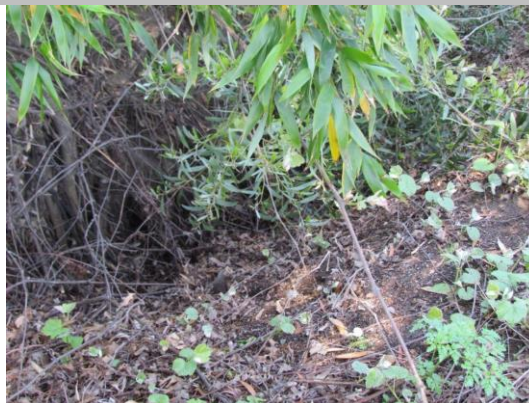
Photo 1 of 2 : SP\_2019\_RD0556\_18\_33\_20190311\_00017.jpg

LM Start	2.72	Rating **	U	Issue No.	33
LM End	2.72	Issue Type +	Ma	Location *	LS
Category	Earthen Levee			GPS Latitude/Longitude	
				Start	End
Item	Slope Stability			38.215107 °	38.215107 °
				-121.540677 °	-121.540677 °
DWR ID	DWR_RD0556_01_s_2017_33				
Comment Code					
S1 : Repair slope instability.					
Inspector Comment					
Fallen tree on landside. Remove the fallen tree and repair the levee damage.

RD 556 Unit 1 levee mile 2.72 fallen tree damage to shoulder and slope.

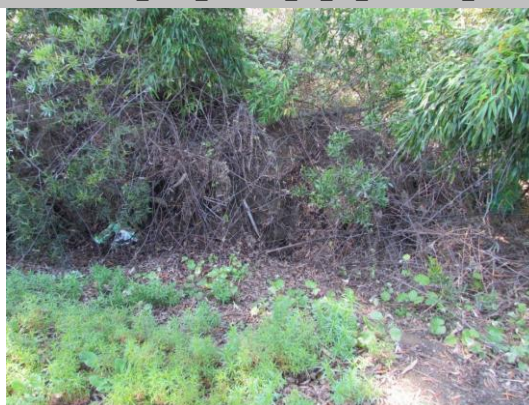
Photo 2 of 2 : SP\_2019\_RD0556\_18\_33\_20190311\_00018.jpg

RD 556 Unit 1 levee mile 2.72 the root ball of the fallen tree on slope landward.

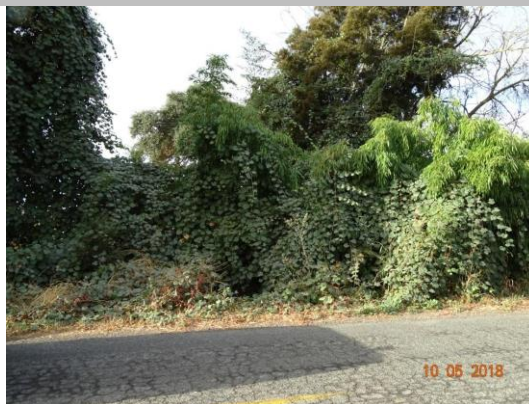
Photo 1 of 1 : SP\_2019\_RD0556\_18\_48\_20190322\_00075.jpg

LM Start	2.73	Rating **	U	Issue No.	48
LM End	2.75	Issue Type +	Ma	Location *	LS
Category	Earthen Levee			GPS Latitude/Longitude	
				Start	End
Item	Vegetation			38.215025 °	38.214955 °
				-121.540623 °	-121.540335 °
DWR ID	DWR_RD0556_01_f_2018_48				
Comment Code					
V2 : Remove the wild growth other than native grasses from the levee slopes.					
Inspector Comment					
Remove wild grapes and bamboo from landside.

View of wild grapes and bamboo on the landside slope (Fall 2018).

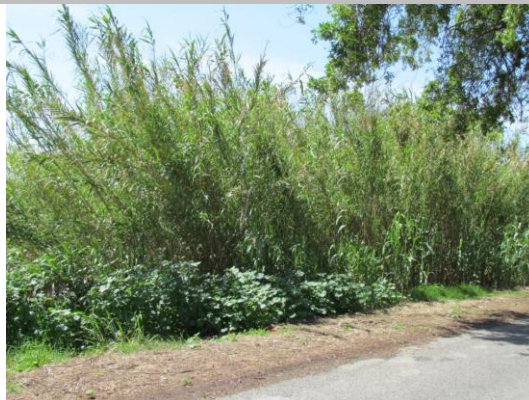
Photo 1 of 1 : SP\_2019\_RD0556\_18\_35\_20190311\_00020.jpg

RD 556 Unit 1 levee mile 3.12-3.14 waterside shoulder and slope.

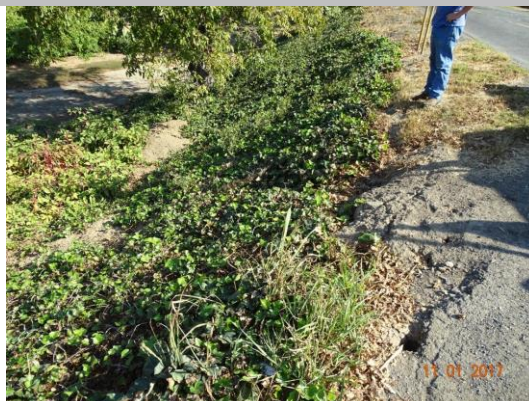
Photo 1 of 1 : SP\_2019\_RD0556\_18\_28\_20190311\_00012.jpg

LM Start	3.14	Rating **	U	Issue No.	28
LM End	3.26	Issue Type +	Ma	Location *	LS
Category	Earthen Levee			GPS Latitude/Longitude	
				Start	End
Item	Animal Control			38.210985 °	38.210160 °
				-121.538372 °	-121.540300 °
DWR ID	DWR_RD0556_01_f_2017_28				
Comment Code					
A1 : Exterminate rodents and backfill and compact or grout burrows.					
Inspector Comment

Significant rodent activity in this area must be stopped. Holes should be backfilled.

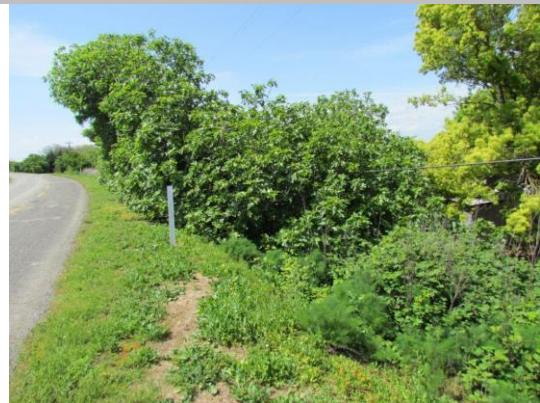
Photo 1 of 1 : SP\_2019\_RD0556\_18\_38\_20190311\_00022.jpg

556 Unit 1 levee mile 3.25-3.29 woody tree growth and vegetation blocking the view of the levee slope and toe.

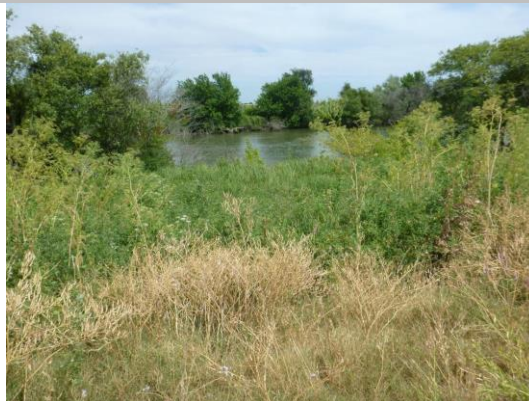
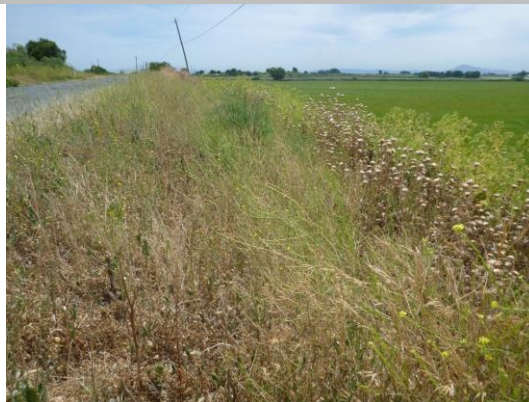
Notes: inactive ditch on landside toe, slope covered in heavy vegetation, minor landside lower slope sloughing observed,

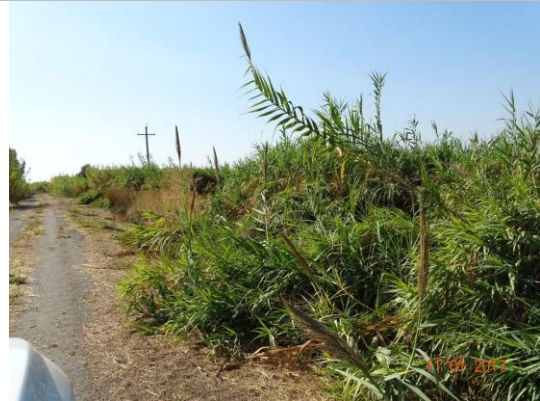
Photo 1 of 1 : SP\_2019\_RD0556\_18\_39\_20190311\_00023.jpg

View of dense growth of wild vegetation, berry vines and arundo on landside slope and toe

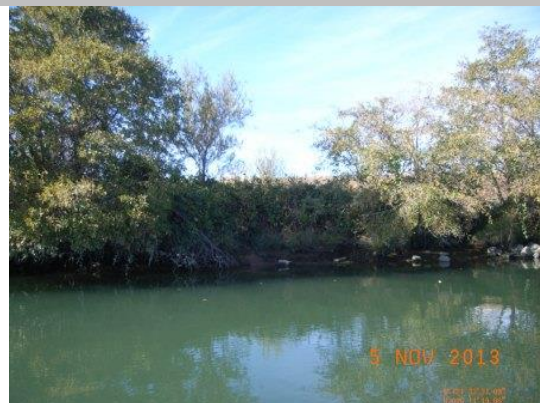
Photo 1 of 1 : SP\_2019\_RD0556\_18\_37\_20190311\_00021.jpg

LM Start	5.12	Rating **	M	Issue No.	37
LM End	5.34	Issue Type +	Ma	Location *	WS
Category	Supplemental			GPS Latitude/Longitude	
				Start	End
Item	2017 USACE Erosion Survey, DRAFT			38.189775 °	38.187369 °
				-121.557729 °	-121.560247 °
DWR ID	DWR_RD0556_01_f_2018_37				
Comment Code					
Inspector Comment					
2017 Site ID: GEO 7.0 R					
Status: Eroding					
2017 Field Notes: Site extended downstream. Large erosion pockets and significant toe erosion.					
Site History: 1997 - Toe damaged rock. 1999 - One pocket filled with gravel. 2000 - Eroding beach with some biotech rolls and stakes; some gravel on slope. 2001 - Staked, low fascine walls at bankline. 2005 - Stone revetment in between pockets. 2006 - New rock on upper slope behind brush boxes at the upstream end, Stone is sliding off the hard toe. 2016 - Fresh erosion observed.

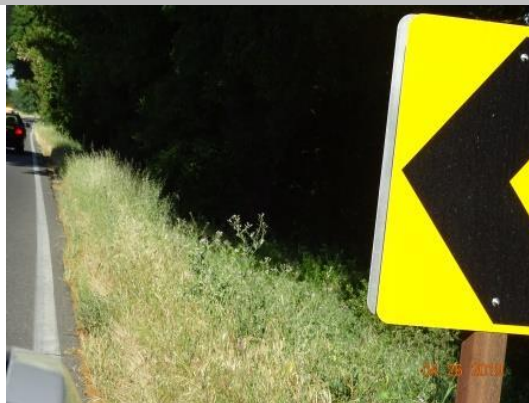
Photo 1 of 1 : SP\_2019\_RD0556\_19\_20\_20190429\_00082.jpg

View looking downstream at annual vegetation on the waterside slope (Spring 2019).

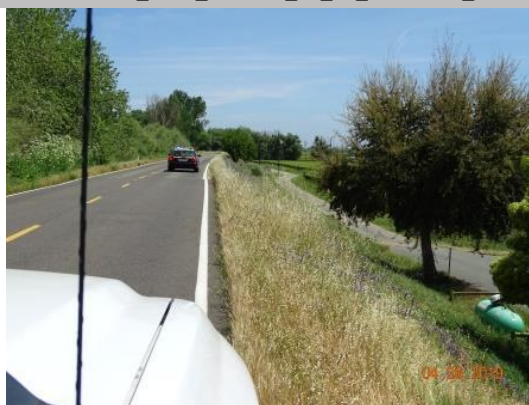
Photo 1 of 1 : SP\_2019\_RD0556\_19\_43\_20190429\_00090.jpg

LM Start	0.00	Rating **	U	Issue No.	43
LM End	5.69	Issue Type +	Ma	Location *	LS
Category	Earthen Levee			GPS Latitude/Longitude	
				Start	End
Item	Vegetation			38.239100 °	38.192013 °
				-121.518250 °	-121.567133 °
DWR ID	DWR_RD0556_02_s_2019_43				
Comment Code					
V1 : Control annual grass and weeds on the levee slopes and easements.					
Inspector Comment					
Maintain the annual vegetation.

View looking downstream at thick vegetation on the landside slope (Spring 2019).

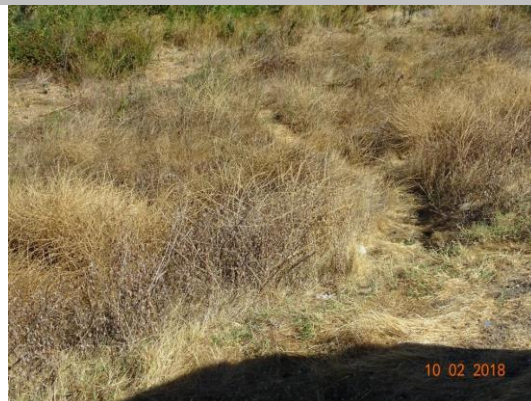
Photo 1 of 1 : SP\_2019\_RD0556\_19\_22\_20190311\_00008.jpg

LM Start	0.39	Rating **	A/W	Issue No.	22
LM End	0.39	Issue Type +	Ma	Location *	WS
Category	Earthen Levee			GPS Latitude/Longitude	
				Start	End
Item	Slope Stability			38.238292 °	38.238292 °
				-121.525362 °	-121.525362 °
DWR ID	DWR_RD0556_02_f_2018_22				
Comment Code					
S1 : Repair slope instability.					
Inspector Comment					
A foot path is digging into levee and should be monitored.

View of footpath down the waterside slope that is beginning to dig into levee (October 2018).

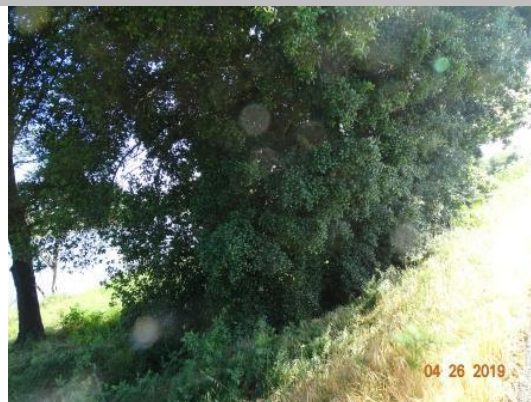
Photo 1 of 1 : SP\_2019\_RD0556\_19\_40\_20190429\_00084.jpg

LM Start	0.44	Rating **	U	Issue No.	40
LM End	0.51	Issue Type +	Ma	Location *	WS
Category	Earthen Levee			GPS Latitude/Longitude	
				Start	End
Item	Trim / Thin Trees			38.238142 °	38.237900 °
				-121.526198 °	-121.527553 °
DWR ID	DWR_RD0556_02_f_2018_40				
Comment Code					
T1 : Trim trees to at least five feet above ground level.					
Inspector Comment

View looking upstream at thick trees on the waterside slope (Spring 2019).

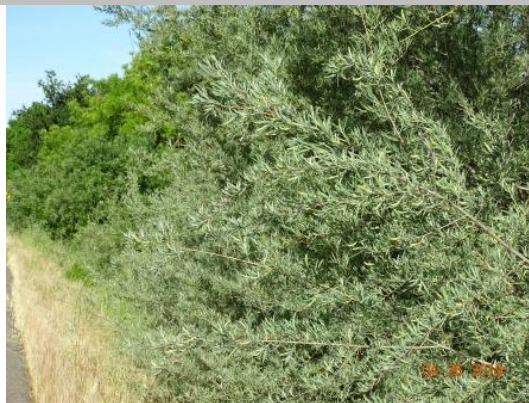
Photo 1 of 1 : SP\_2019\_RD0556\_19\_51\_20190429\_00083.jpg

View looking downstream at wildgrowth on the waterside slope (Spring 2019).

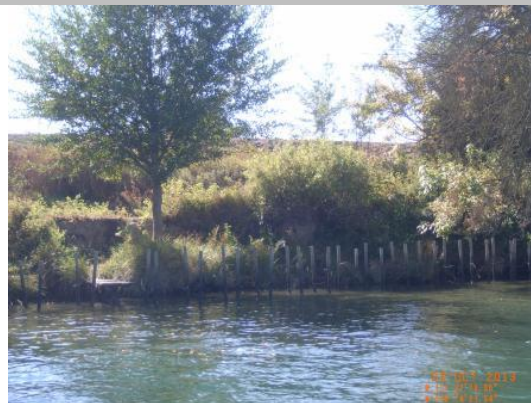
Photo 1 of 1 : SP\_2019\_RD0556\_19\_19\_20190311\_00007.jpg

LM Start	1.03	Rating **	M	Issue No.	19
LM End	1.15	Issue Type +	Ma	Location *	WS
Category	Supplemental			GPS Latitude/Longitude	
				Start	End
Item	2017 USACE Erosion Survey, DRAFT			38.238772 °	38.239265 °
				-121.536788 °	-121.538845 °
DWR ID	DWR_RD0556_02_f_2018_19				
Comment Code					
Inspector Comment					
2017 Site ID: SAC 25.2 L Status: Eroding 2017 Field Notes: Minor new erosion observed. Site History: 1997 - Rock is in poor condition and has failed in many places. Scallops in berm with remnants of old rock in the toe area. 2005 - Brush boxes present. 2013 - Site extended upstream approximately 300 ft to include new erosion pockets. 2015 - Minor new erosion at toe.

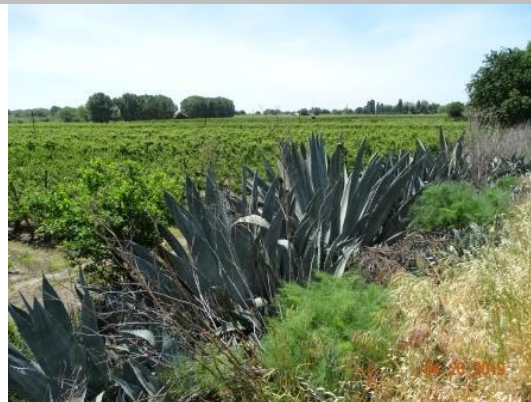
Photo 1 of 1 : SP\_2019\_RD0556\_19\_47\_20190429\_00092.jpg

LM Start	1.57	Rating **	U	Issue No.	47
LM End	1.57	Issue Type +	Ma	Location *	LS
Category	Earthen Levee			GPS Latitude/Longitude	
				Start	End
Item	Vegetation			38.240455 °	38.240455 °
				-121.546362 °	-121.546362 °
DWR ID	DWR_RD0556_02_s_2019_47				
Comment Code					
V2 : Remove the wild growth other than native grasses from the levee slopes.					
Inspector Comment					
Remove cactus from the landside slope.

View looking downstream at cactus on the landside slope (Spring 2019).

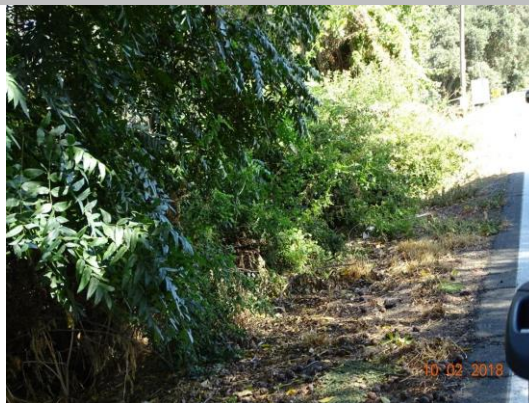
Photo 1 of 1 : SP\_2019\_RD0556\_19\_71\_20190311\_00035.jpg

View looking upstream at vegetation on waterside slope (October 2018).

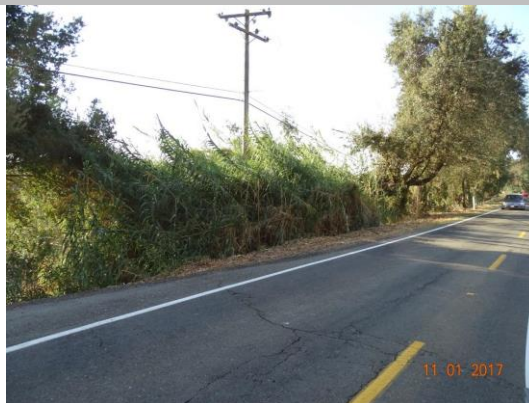
Photo 1 of 1 : SP\_2019\_RD0556\_19\_32\_20190311\_00016.jpg

View of arundo on the landside slope and toe.

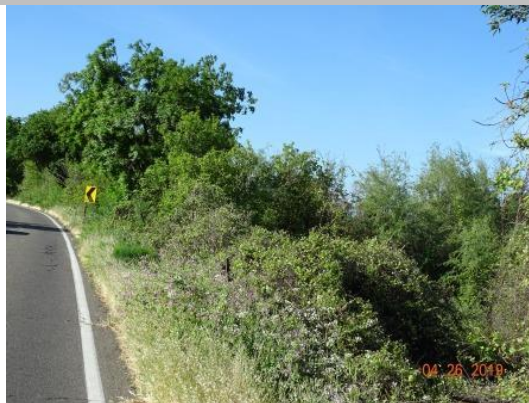
Photo 1 of 1 : SP\_2019\_RD0556\_19\_21\_20190429\_00085.jpg

View looking downstream at thick wildgrowth on the waterside shoulder (Spring 2019).

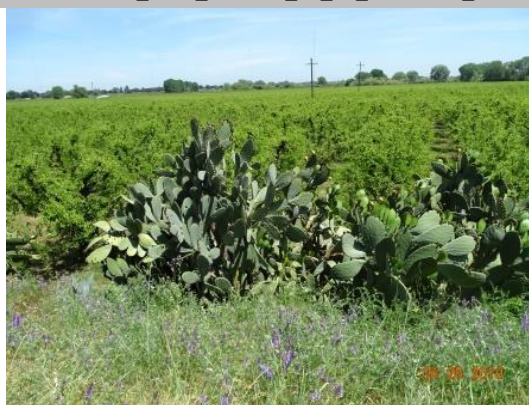
Photo 1 of 1 : SP\_2019\_RD0556\_19\_45\_20190429\_00091.jpg

LM Start	2.43	Rating **	U	Issue No.	45
LM End	2.43	Issue Type +	Ma	Location *	LS
Category	Earthen Levee			GPS Latitude/Longitude	
				Start	End
Item	Vegetation			38.235036 °	38.235036 °
				-121.558011 °	-121.558011 °
DWR ID	DWR_RD0556_02_s_2019_45				
Comment Code					
V2 : Remove the wild growth other than native grasses from the levee slopes.					
Inspector Comment					
Remove cactus from the landside slope.

View of cactus on the landside slope (Spring 2019).

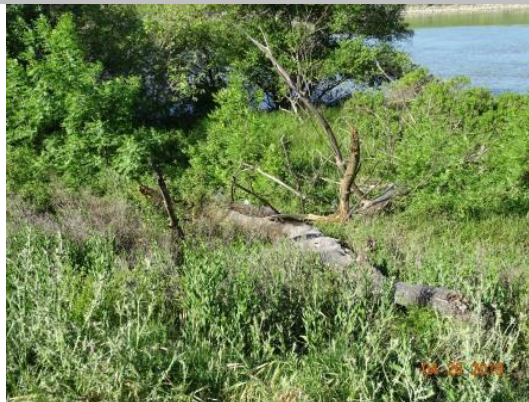
Photo 1 of 1 : SP\_2019\_RD0556\_19\_44\_20190429\_00086.jpg

LM Start	2.69	Rating **	M	Issue No.	44
LM End	2.69	Issue Type +	Ma	Location *	WS
Category	Earthen Levee			GPS Latitude/Longitude	
				Start	End
Item	Encroachments			38.231494 °	38.231494 °
				-121.556474 °	-121.556474 °
DWR ID	DWR_RD0556_02_s_2018_44				
Comment Code					
TR : Tree or limb					
Inspector Comment					
Remove fallen tree from the waterside shoulder.

View of fallen tree within 20' of the waterside shoulder (Spring 2019).

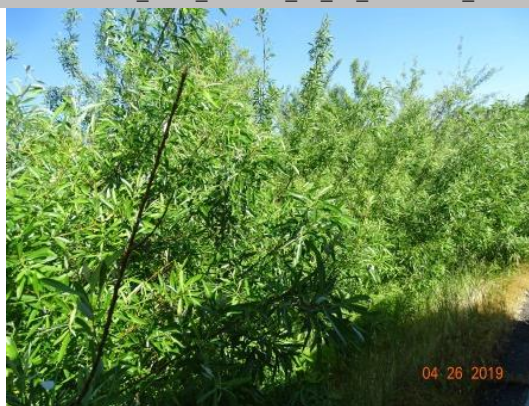
Photo 1 of 2 : SP\_2019\_RD0556\_19\_76\_20190429\_00088.jpg

View looking upstream at thick wildgrowth on the waterside slope (Spring 2019).

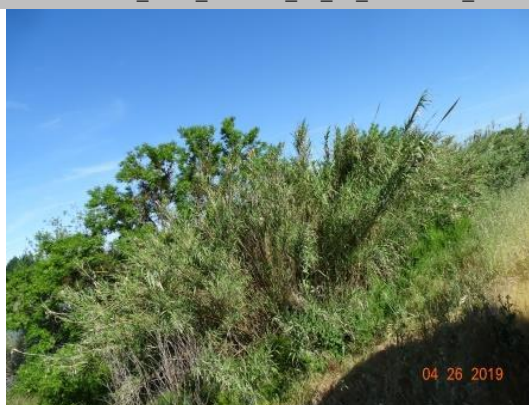
Photo 2 of 2 : SP\_2019\_RD0556\_19\_76\_20190429\_00089.jpg

View looking upstream at arundo on the waterside slope (Spring 2019).

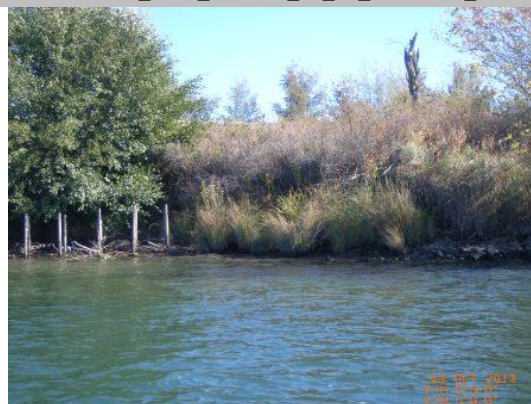
Photo 1 of 1 : SP\_2019\_RD0556\_19\_16\_20190311\_00004.jpg

LM Start	3.58	Rating **	M	Issue No.	16
LM End	3.64	Issue Type +	Ma	Location *	WS
Category	Supplemental			GPS Latitude/Longitude	
				Start	End
Item	2017 USACE Erosion Survey, DRAFT			38.218951 °	38.218104 °
				-121.556689 °	-121.556819 °
DWR ID	DWR_RD0556_02_f_2018_16				
Comment Code					
Inspector Comment					
2017 Site ID: SAC 22.7 L Status: Eroding 2017 Field Notes: Minor new erosion at toe. Site History: 1997 - Scallops into berm and very close to levee toe. 2005 - Brush boxes present. 2011 - New toe scour and freshly fallen tree. 2012 - New tree popout has taken significant portion of soil out of the levee.

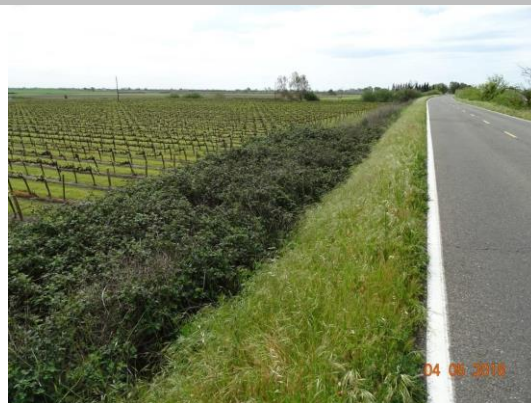
Photo 1 of 1 : SP\_2019\_RD0556\_19\_52\_20190311\_00026.jpg

View of berry vines on landside.

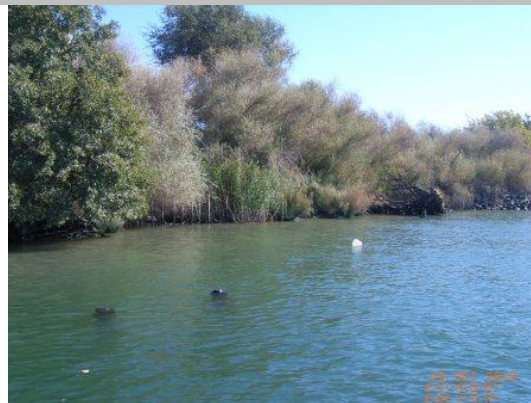
Photo 1 of 1 : SP\_2019\_RD0556\_19\_14\_20190311\_00002.jpg

LM Start	4.45	Rating **	M	Issue No.	14
LM End	4.49	Issue Type +	Ma	Location *	WS
Category	Supplemental			GPS Latitude/Longitude	
				Start	End
Item	2017 USACE Erosion Survey, DRAFT			38.206377 °	38.205729 °
				-121.557184 °	-121.557108 °
DWR ID	DWR_RD0556_02_f_2018_14				
Comment Code					
Inspector Comment					
2017 Site ID: SAC 21.9 L					
Status: Eroding					
2017 Field Notes: No observed change..					
Site History: 2013 - Erosion pockets encroaching on levee foundation.

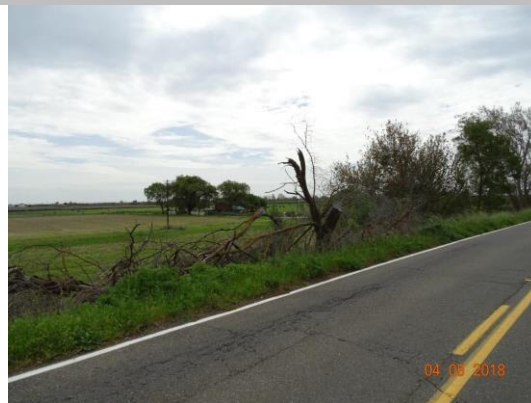
Photo 1 of 1 : SP\_2019\_RD0556\_19\_56\_20190311\_00029.jpg

Fallen tree on landside should be removed.

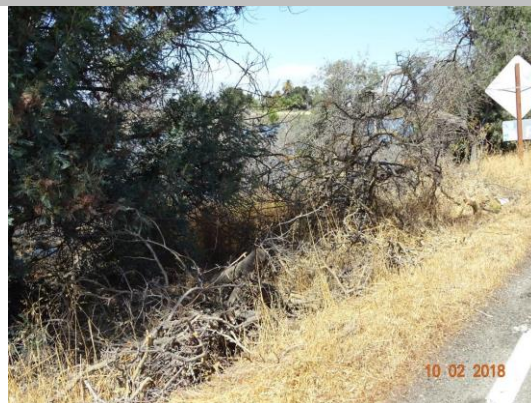
Photo 1 of 1 : SP\_2019\_RD0556\_19\_27\_20190311\_00011.jpg

View of fallen tree on the waterside slope (October 2018).

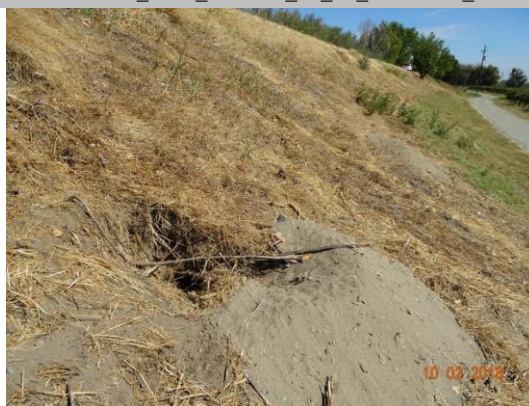
Photo 1 of 1 : SP\_2019\_RD0556\_19\_79\_20190311\_00038.jpg

View looking upstream at burrow holes on land side slope. (October 2018).
